PROJECT PROFILE

2011 LAKE MCKUSICK BIORETENTION

Project Summary

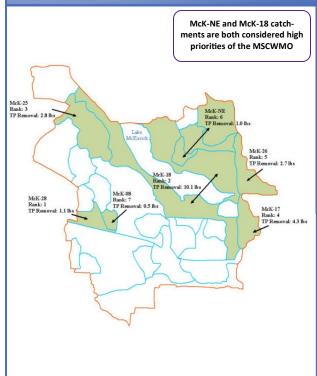
Lake McKusick Priority Catchments

Within the subwatershed assessment, catchments McK-NE and McK -18 were identified for several retrofit projects intended to:

The catchments consist of residential development with a high percentage of impervious cover. The table below highlights important characteristics of the catchment as well as WinSLAMM model outputs of total phosphorus (TP), total suspended solids (TSS), and volume contributions prior to bioretention cell installation.

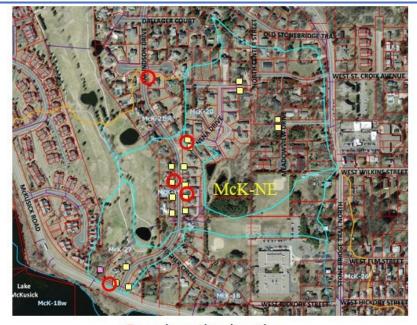
O raingarden location

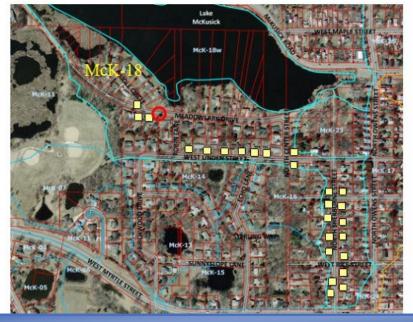
Project locations within catchments McK-NE and McK-18

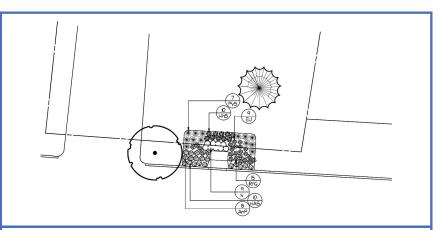
Example planting plan design, developed by WCD staff. The selected contractor was able to complete all project sites using the WCD designs and materials lists.

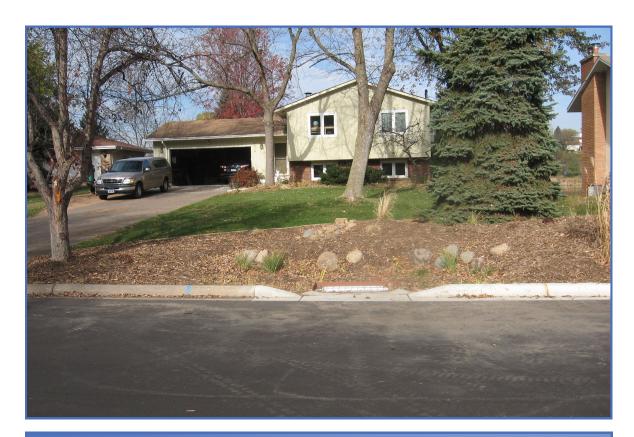
Completed bioretention cell, October 2011. Inlet pretreatment box chamber prevents debris and sediment entry into the bioretention cell. Lake McKusick is visible in the background.

Post-project monitoring verified acceptable vegetation establishment and proper pretreatment function following storm events. Monitoring will continue to ensure proper long-term functionality and vegetation quality.
