Lake St. Croix Direct Discharge (South) Stormwater Retrofit Analysis

February 20, 2018

Lake St. Croix Direct Discharge (South) - Stormwater Retrofit Analysis

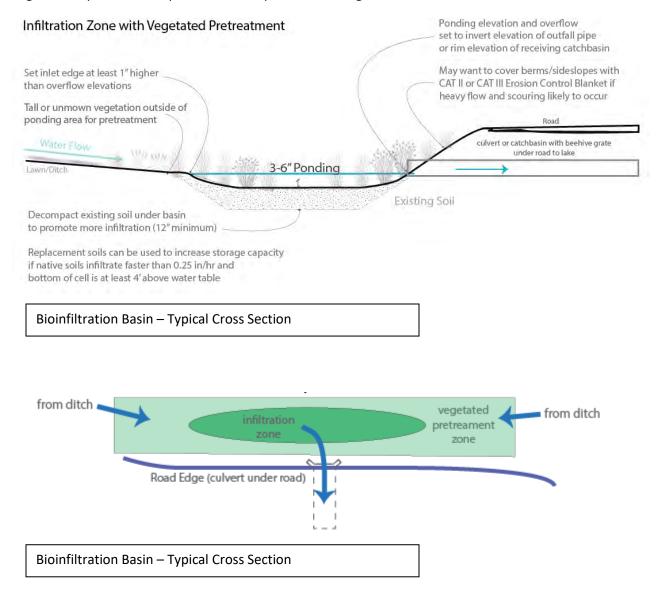
Bioinfiltration

BioInfiltration is a basin that infiltrates into the native soil fast enough to allow for a fully drained basin within 48 hours. There are no underdrains in a BioInfiltration Basin. All basins of either type in the analysis do not have pretreatment devices to limit gross solid accumulation and rely on additional tall vegetation upstream to capture sediment prior to entering the basin.

Biofiltration, Bioinfiltration, and Ponded Swales were the three retrofit BMPs identified throughout the analysis area. The typical cross-sections below describe the design assumptions used in the cost estimation process.

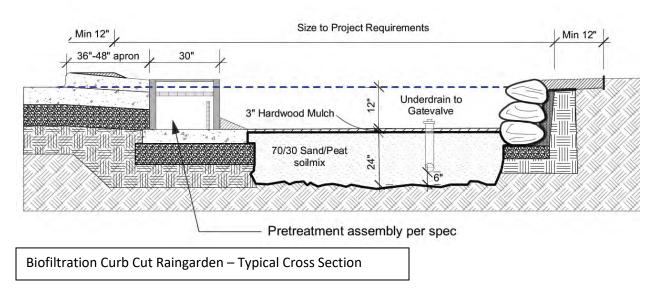
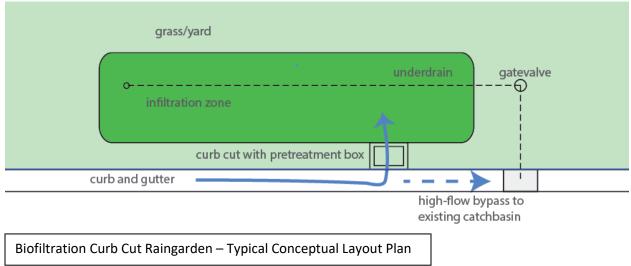
Biofiltration is bioretention basin that requires an underdrain. This is usually required when soils do not infiltrate fast enough or when there is a need for a liner beneath the cell. Cleanouts and gatevalves will typically accompany the draintile assembly. All basins of either type in the analysis do not have pretreatment devices to limit gross solid accumulation and rely on additional tall vegetation upstream to capture sediment prior to entering the basin.

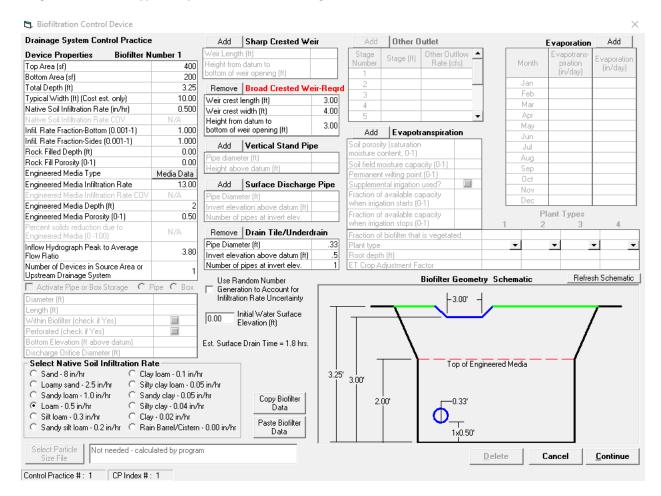
Biofiltration Modeling

The WinSLAMM model inputs curb cut raingardens are typically modelled per unique site-specific conditions; including catchment boundaries, soil conditions, and underdrain connection opportunities. Infiltration media is modelled as a 70% blend of sand with 30% peat. Sediment pretreatment devices such as the RainGuardian Bunker box are not included in the WinSLAMM model design. Refer to diagram below for typical inputs of a curb cut raingarden.

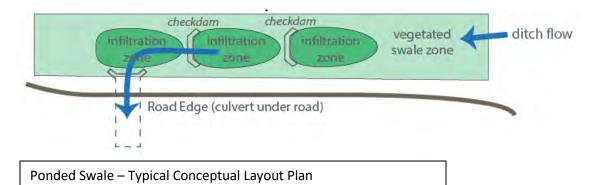
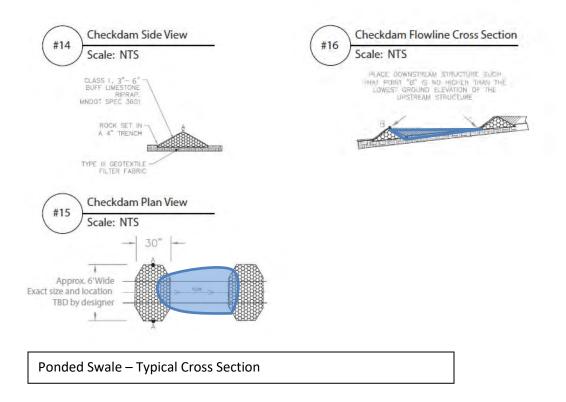
Ponded Swales

Ponded swales are essentially a flow-through (or in-line) BioInfiltration basin. Some sort of detention device will be installed at the downstream end of the swale to promote ponding at a specified depth (riprap check dam or earthen berm). The ponding area created allows for increased treatment of TP and TSS, and is a form of volume control as well. All swales with checkdams were modelled with 3-6" of ponding and would mimic the native soil infiltration rate. Swales without checkdams are also recommended, and soils were modelled with the native soil infiltration rate since the practices are based on stripping the existing sod and accumulated sediment and ripping deep into the soil until you hit the native soils again.

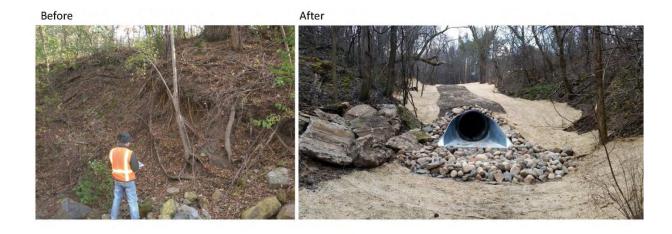
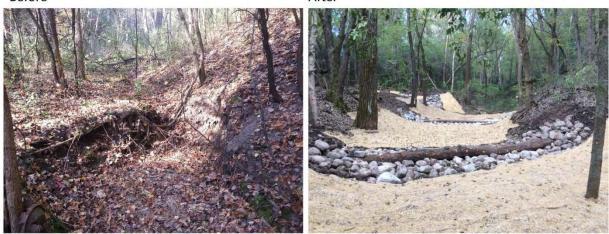
Ravines Stabilization

Ravine stabilization can take many forms. Stabilization usually uses some combination of check dams or grade stabilization (listed on previous pages), toe stabilization, and revegetation. Ravines are also stabilized by controlling the upstream volume contributing to the erosion. This is achieved by installing infiltration basins where possible. Sometimes water can be diverted away from, or piped down through, the ravine entirely. Ravine stabilizations are modelled with the BWSR Pollution Reduction Spreadsheets. The reductions are calculated based on the practices prescribed and vary from 100% reduction rates for diversions to as low as 25% reduction rates for headcut stabilization. These values are added to any upstream reductions for infiltration practices. See Methods discussion on previous pages to understand modelling assumptions used in this report. Below are typical Before and After images of a ravine stabilization. (*images courtesy of the Valley Branch Watershed District*)

Before

After

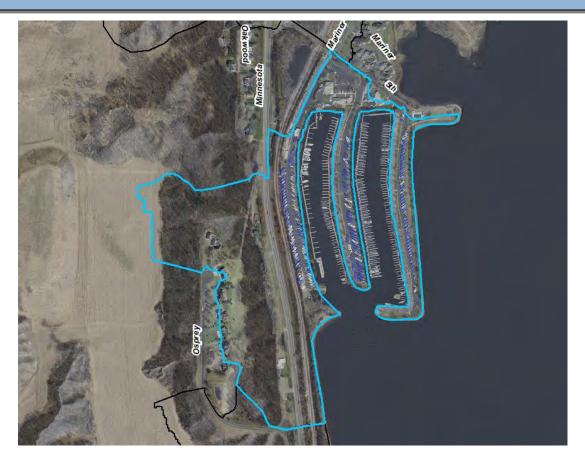
Catchment SD-37

EXISTING CONDITIONS						
Existing Conditions		Base Loading	Treatment	Net Treatment %	Existing Loading				
	TP (lb/yr)	24.9	0.0	0%	24.9				
÷	TSS (lb/yr)	18,584	0.0	0%	18,584				
men	Volume (acre-feet/yr)	24.59	0.0	0%	24.6				
Treatment	Number of BMP's	0							
E.	BMP Size/Description								
	ВМР Туре	No known BMPs exist

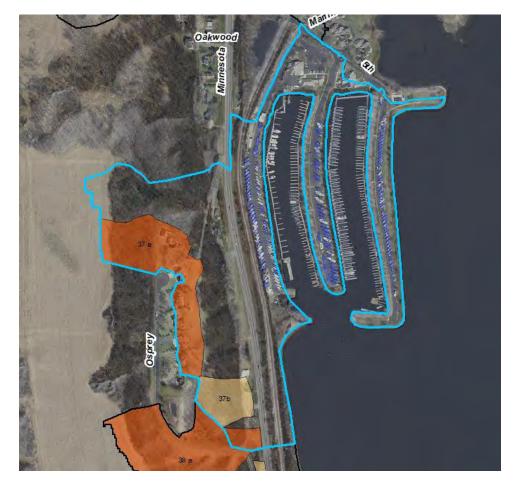
RANK 13/19 - BMP 37 a – Osprey Blvd Infiltration Basin(s): 1 large (or 5 small) infiltration basins on bluff in properties along Osprey Blvd.

RANK 19/19 - BMP 37 b – Infiltration Basin: Infiltration basin capturing steep bluff and impervious lot

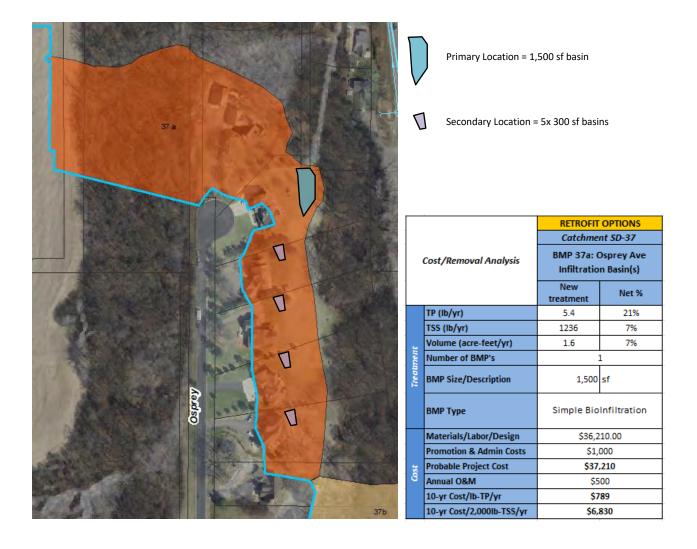
BMP-37a: Osprey Blvd Infiltration Basin(s)

Location – North end of Osprey Blvd, in backyards above bluff Property Ownership – Private

Description – Much water flows down the wooded upper bluff, through the residential parcels, and down the lower bluff. Flows are directed both through a commercial parking lot as well as down an old access drive. The wooded slopes are very steep and have quite a bit of buckthorn and bare understory. Even though the canopy is dense and protects the slope from smaller events, it is assumed that most of the erosion occurs once flows get moving down the bluff in larger rain events. The practice recommended can take one of two forms: 1) 1 large 1500sf infiltration basin at 925 Osprey Blvd above the lower bluff outlet or 2) up to 5 small 300sf infiltration basins across the back lots along Osprey Blvd. Both options would be 6" ponding, and would take advantage of the sandy native soils for maximum infiltration. There are septic systems in the backyards, and the homes are built within 125' of the bluff top. Design considerations include avoiding the septic drain fields and to avoid hyper-saturating the bluff edge.

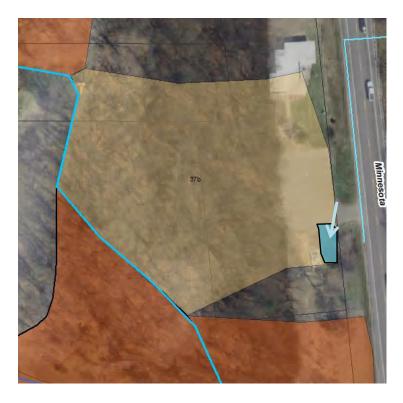
BMP -37b: Infiltration Basin

Location – Below bluff at north end of Osprey Blvd, on Hwy 95 Property Ownership – Private

Description – The practice ranks low relative to the others in this study, but is still well below the norm of \$1,500-\$3,000 per lb of TP of typical curb-cut raingardens. This BMP would rank very high in most other studies. This practice would take the water from the steep bare bluff that flows through the large parking lot. A channel drain would be inserted across the top of the driveway and redirect flows to an infiltration basin to the south edge of the lot. The soils are sandy and would likely require some decompaction. This basin could be fitted with an underdrain (allowing capture of larger rain events) since there is a catchbasin below the top of the hill where the basin will sit. A pretreatment device would also be necessary to contain the large sediment load flowing from the bluff.

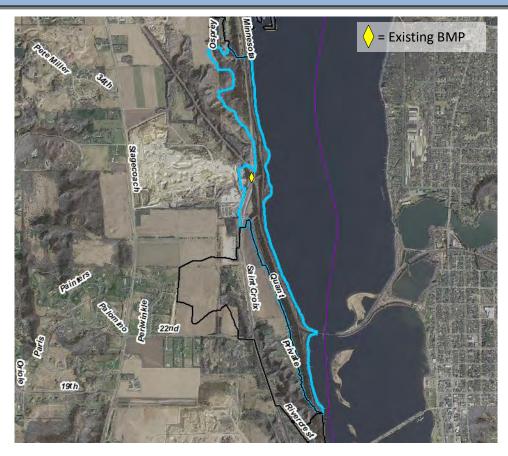
EXISTING CONDITIONS						
	Existing Conditions	Base Loading	Treatment	Net Treatment %	Existing Loading				
	TP (lb/yr)	46.6	0.0	0%	46.6				
-	TSS (lb/yr)	40,458	0.0	0%	40,458				
ine in	Volume (acre-feet/yr)	26.70	0.0	0%	26.7				
Trea tmen	Number of BMP's	1							
Tre	ВМР Туре	Small non-functional basin @ SE of railroad bridge (Hwy

Catchment SD-38 is 111.57 acres. It is primarily a bluff-top catchment with large tracts of open space (some degraded, most in good to great condition). The main contributors of pollutants to this area would be the impervious surface associated with the highway, erosion on the bluff faces, and the large gully contributions at the intersection of the railway and Highway 95.

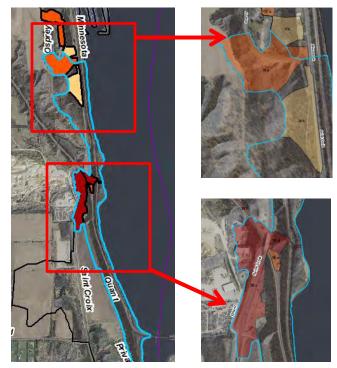
RANK 02/19 - BMP 38 d2 – Combined Gully Load Reductions: Factors in all recommended practices affecting gully erosion – includes BMP 38c, 38d, 38e, and adds direct gully losses to the total load. RANK 05/19 - BMP 38 d – Divert to 38c ditch+ reinstall 38d basin: After fixing 38c ditch system, divert remaining water into former sediment basin and redirect overflow away from Gully 38d.

RANK 09/19 - BMP 38 c – Infiltration Basin: repair 38c ditch system, armor headcut, and improve upon existing failed BMP

RANK 10/19 - BMP 38 e – Simple Infiltration + Sediment Cleanout: Divert flow away from Gully 38d through sediment cleanup, swale regrade, and simple infiltration basin construction

RANK 11/19 - BMP 38 a – Complex Infiltration Basin: Use new structure to divert low flows of Osprey Ave to off-line infiltration basin, high flows bypass to existing stormsewer.

RANK 16/19 - BMP 38 b – Moderately Complex Infiltration Basin: Curb Cut infiltration basin to receive water from Hwy 95 and bluff. Offline design with underdrain.

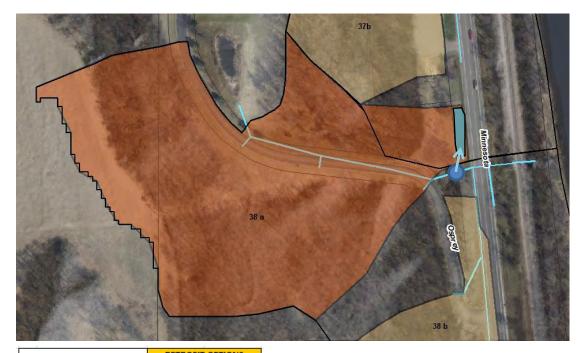
BMP - 38a: Complex Infiltration Basin

Location – South end of Osprey Blvd, on Hwy 95 ROW Property Ownership – Public (private if necessary)

Description – The bluff above Osprey Blvd is fairly steep, with a mix of buckthorn and bare soils in some places, and moderate native groundcover in others. The bluff flows onto Osprey and flows to any of 6 catchbasins down the steep road. There is opportunity to divert low flows from the main stormsewer, below the bluff along Hwy 95, into a 1,500sf infiltration basin. An underdrain should be able to connect to the existing stormsewer on Hwy 95. All high flows will bypass through the main stormsewer line once the basin is full. It should be verified how frequently the stormpond at the top of the catchment overflows in order to determine the appropriate high-flow bypass configuration. It appears to have ample capacity, especially above the native sandy soils.

Basin Location = 1,500 sf bas	sin
Basin Location – 1,500 Si Das	5111

Low Flow Diversion/High Flow Bypass Structure

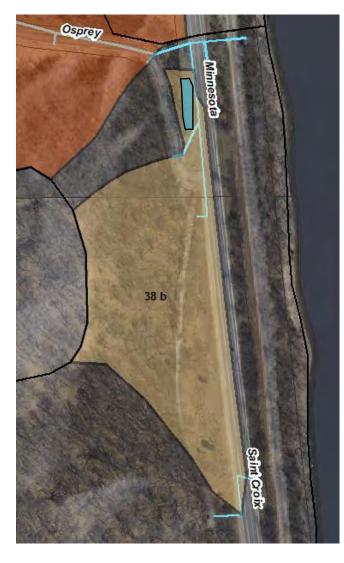
BMP-38b: Curb Cut Infiltration Basin

Location – South end of Osprey Blvd, along Hwy 95 Property Ownership – Public/Private

Description – This practice would take the water from the steep bluff that flows directly onto Highway 95. There is not much room for an adequate sized ditch for pretreatment, so a pretreatment device will have to be installed as part of the curb-cut inlet. Significant soil removal will have to occur to make this basin fit the curbline. The catchbasin depth will need to be verified by survey to determine if an underdrain connection is possible (visual inspection could not determine if adequate depth existed). The cost estimate was inflated to account for a potential fieldstone wall on the back edge of the basin. If soil can be disposed of onsite and the backslope can be regraded without a wall, then the cost and ranking should improve considerably.

Curb Cut Basin Location = 1,500 sf

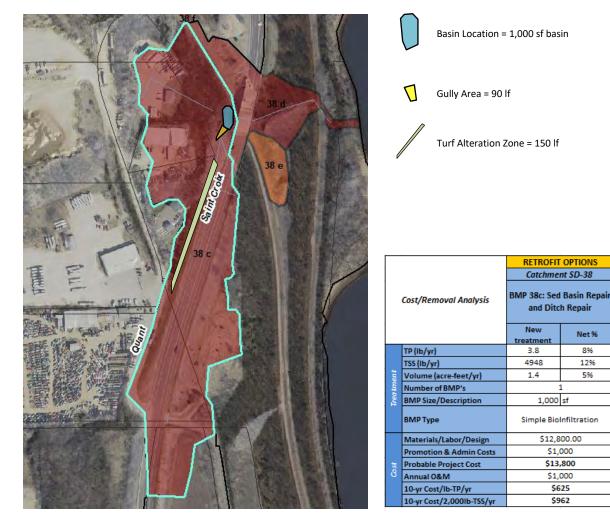
BMP-38c: Sediment Basin and Ditch Repair

Location – West side of Hwy 95, at intersection of railroad tracks and highway bridge **Property Ownership** – Private/Public

Description – South of the bridge on the west side of Hwy 95, the ditch system is being bypassed and flows into a catchbasin in 38d, and flows back under the bridge causing major headcutting of the ravine and undercutting the bridge foundation. To stop the headcutting, multiple projects have to be in place. BMP 38c is the easiest of the three projects recommended in this study to fix the headcut down 38d to the river. This first calls for amending the western highway edge by excavating the first few feet of sod, and lowering the sod to a new elevation that will allow water to enter the ditch from the road again. This will prevent the bypass of flow into subcatchment 38d. Second, there is a catchbasin with a very small sediment basin that once was functioning below the bridge (intercepting flow from the industrial site above the bluff and highway 95). This basin is clogged and there is much gully erosion contributing to this site. Stabilize gully with simple riprap checkdam treatment and hydroseed. Excavate basin to 1000sf, at 1.5' ponding depth. Annual inspection and cleanout will be necessary to keep this basin functioning.

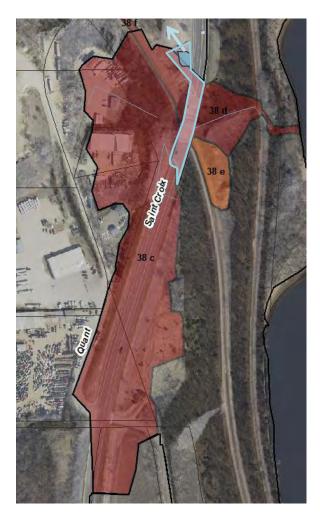
BMP-38d: Infiltration Basin

Location – NW Corner of Highway 95 bridge at Railroad Tracks Property Ownership – Public

Description – There is an old basin at the NW corner of the bridge. It appears to have functioned at one point in time, then it seems that the drainage was re-routed so the it bypassed the basin and now flows directly underneath the bridge and through the eroding gully at 38d. This practice would utilize the old basin footprint, install a new inlet and outlet structure, and leave the remaining basin bottom alone. Water would flow through this basin at a maximum 1' ponding depth and overflow down into the bottom of the ravine adjacent to the SNA to the north. This new receiving area is entirely disconnected from the St Croix River.

New Catchment Boundary

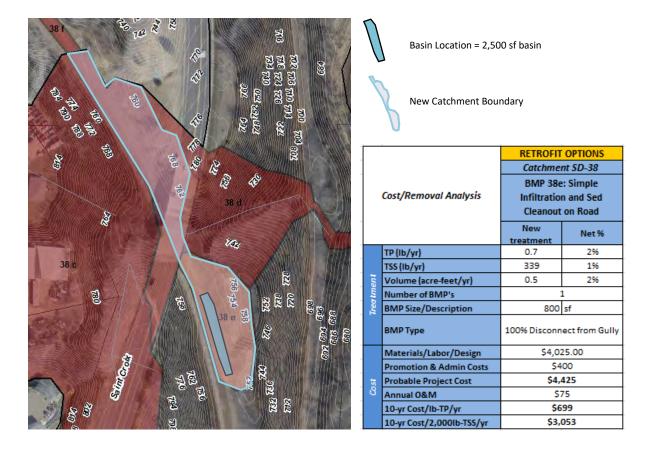
BMP-38e: Infiltration Basin

Location – SE Corner of intersection of Highway 95 bridge and railroad tracks *Property Ownership* – Public

Description – This practice would be necessary if it is decided to disconnect as much flow from the eroding 38d gully as possible. Currently, there is about 1-2' of sediment buildup along the railroad access path. This buildup is the accumulation of erosion from 38c, and subsequently diverts runoff from the railroad grade down the 38d gully, eroding the footing of the bridge in the process. If this sediment is excavated deep enough, water can be diverted from gully head and further south along the railroad access path along a 1.5% grade (steeper if more flushing of sediment is desired). This swale will outlet into a large sandy basin that is disconnected from the 38d gully. This basin should only pond to a 6" depth and overflow should be safely directed further down the railgrade or down the bluff. This is a very inexpensive fix and should only be completed if 38c and 38d have been constructed first. The low point near the 38d gully head should be monitored annually to prevent sediment buildup and recurring bypass back into the gully again.

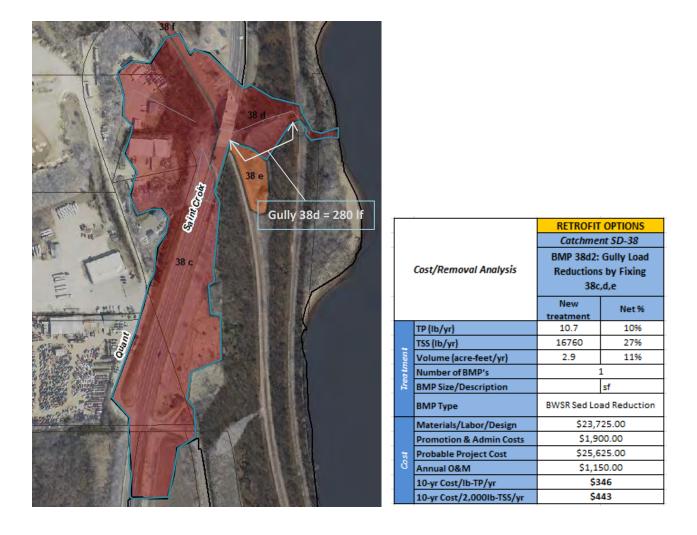
BMP-38d2: Gully Load Reductions from 38c, d, e

Drainage Area – 11.81 acres (38c and 38d combined) Location – Intersection of Highway 95 and railroad tracks Property Ownership – Public/Private

Description – BMP 38d2 is the gully erosion reduction from the combined implementation of practices 38c, 38d, and 38e. This assumes all practices recommended for this system are installed. The erosion down this gully is extensive and is the result of the combined effects of multiple failed practices. The gully pollutant load was calculated using the BWSR Pollution Reduction Spreadsheets. The individual load reductions from 38c, 38d and 38e were then added to the gully erosion numbers from the BWSR Spreadsheets (10.7 lbs/yr TP combined). The gully erosion was calculated as having begun when the bridge was created around 1965. Resulting TP and TSS reductions for fixing the gully were conservatively discounted by 50% to account for the unknown effects of catastrophic rain events that would still contribute to gully erosion.

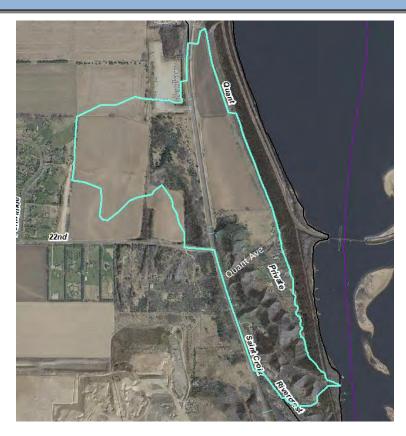
Catchment SD-39

Existing Conditions		EXISTING CONDITIONS						
		Base Loading	Treatment	Net Treatment %	Existing Loading			
Trea tment	TP (lb/yr)	33.4	0.0	0%	33.4			
	TSS (lb/yr)	13,062	0.0	0%	13,062			
	Volume (acre-feet/yr)	18.72	0.0	0%	18.7			
	ВМР Туре		no existin	gpratices

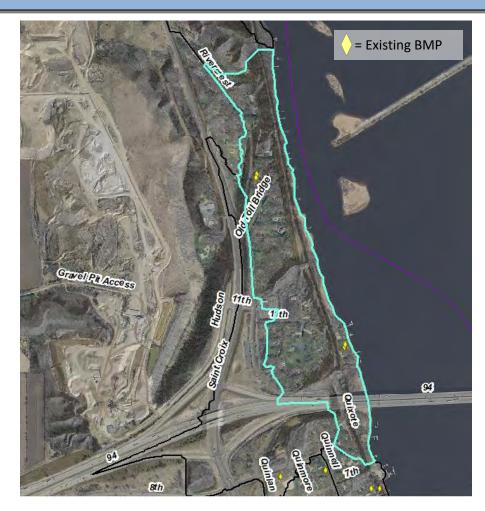
Catchment SD-40

EXISTING CONDITIONS									
Existing Conditions		Base Loading	Treatment	Net Treatment %	Existing Loading				
Trea tment	TP (lb/yr)	56.4	3.8	7%	52.6				
	TSS (Ib/yr)	73,260	1,542	2%	71,718				
	Volume (acre-feet/yr)	18.96	2.3	12%	16.7				
	BMP Type	Infiltration Basins and Swales

Two known properties have BMPs installed. One is a large infiltration cell and swale on Rivercrest (above the bluff) and the other is a shoreline and raingarden below the bluff. Both were incorporated into this existing conditions model. Also included in the Base Loading model is the load reduction for BMP 40m. This is to accurately account for the load reduction of 40m in the final calculations.

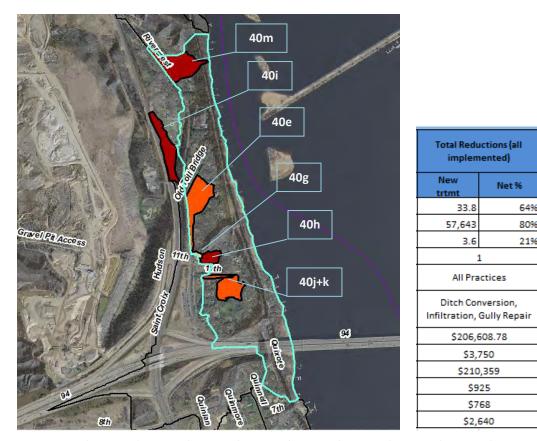
RANK 01/19 - BMP 40m – Private Bluff Restoration: Eliminate bluff losses on 1 private property
 RANK 06/19 - BMP 40h – Bungalow Infiltration (large): Large Infiltration cell at The Bungalow
 RANK 08/19 - BMP 40i – Hwy 95 Headcut Repair + Flow Disconnect: Disconnect Highway 95 drainage
 RANK 12/19 - BMP 40j + 40k – 11th St Infiltration System: Infiltration and swales above bluff on 11th St
 RANK 15/19 - BMP 40e – Rivercrest Ditch Conversion + Ravine Stabilization: Convert mown ditches to infiltration swales and restore ravine with checks and toe stabilization

RANK 18/19 - BMP 40g – Bungalow Infiltration (small): Small Infiltration cell at The Bungalow

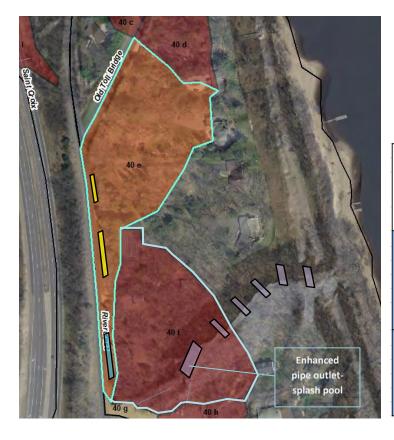
Ravine Stabilization and Checkdams

Description – There is an opportunity to dramatically reduce the volume heading to Gully 40f (near the Bungalow Restaurant). The existing ditches along the east side of Rivercrest flow to Gully 40f; with the majority of the ditch system being mowed routinely by homeowners or maintenance crews. The swales were likely constructed when Rivercrest was reconstructed in the early 1960's. If five decades of sediment buildup could be stripped from the ditches, the native sandy soils would be exposed and would allow much more water to infiltrate in transit to the gully. Further, the ditches could be retrofit with checkdams to induce 6" max ponding depths, and the vegetation would be converted to native perennials. The final Ponded Swale would allow up to 12" of ponding with a more robust overflow to the gully. This system could be less expensive to construct (thus ranking even higher) if exposure of native soils only occurred in select areas (instead of entire ditch length).

In the gully, restoration will occur at the pipe outfall, at regular intervals, and at problem zones. At the outfall, a large riprap splash pool will be installed to dissipate flow energy. This pool can be fit with or without a large underdrain to help drainage. At regular intervals and at problem points down the gully, riprap checkdams will be installed. Some side-slope toe stabilization may have to occur at critical turns in the flow path. Flows at the pipe outfalls should be modelled to determine proper stabilization methods.

Amended Swale = 800-1600 sf each

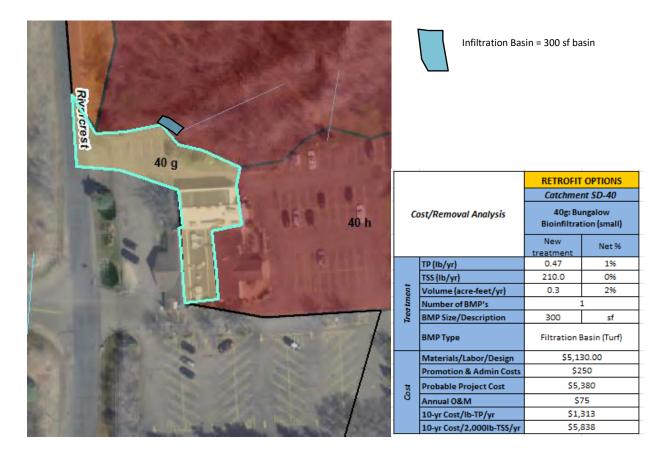
BMP-40g: Bungalow Infiltration Basin (small)

Location – NW Corner of The Bungalow parking lot Property Ownership – Private

Description – This is a small volume control practice that would reduce runoff to Gully 40f and would also serve as treatment for snow melt (from plow storage). It would be a 300 sf turf basin, unless owners wanted perennials for cover. There would be a pretreatment device installed unless it would interfere with snow storage. Maximum ponding depth would be 9" deep. The basin could be fit with an underdrain if desired (helping turf survival), and underdrain would outlet to the gully.

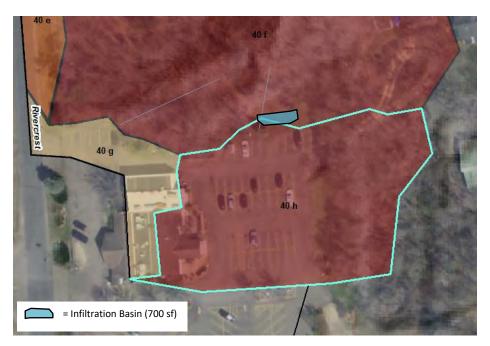
Location – North edge of The Bungalow parking lot *Property Ownership* – Private

Description – This is a volume control practice that would reduce parking lot runoff to Gully 40f and would also serve as treatment for snow melt (from plow storage). It would be a 700 sf turf basin, unless owners wanted perennials for cover. There would be a pretreatment device installed unless it would interfere with snow storage. Maximum ponding depth would be 9" deep. The basin could be fit with an underdrain if desired (helping turf survival), and underdrain would outlet to the gully.

RETROFIT Catchmei		
Cost/Removal Analysis		40h: Bungalow Bioinfiltration (large)		
		New treatment	Net %	
	TP (Ib/yr)	2.65	5%	
lrea tmen t	TSS (Ib/yr)	761.0	1%	
	Volume (acre-feet/yr)	1.1	7%	
	Number of BMP's	1		
Tree	BMP Size/Description	700	sf	
	ВМР Туре	Filtration Basin (Turf		
	Materials/Labor/Design	\$13,0	13.78	
	Promotion & Admin Costs	\$2	50	
Cost	Probable Project Cost	\$13,	264	
8	Annual O&M	\$7	75	
	10-yr Cost/lb-TP/yr	\$5	29	
	10-yr Cost/2,000lb-TSS/yr	\$3,6	583

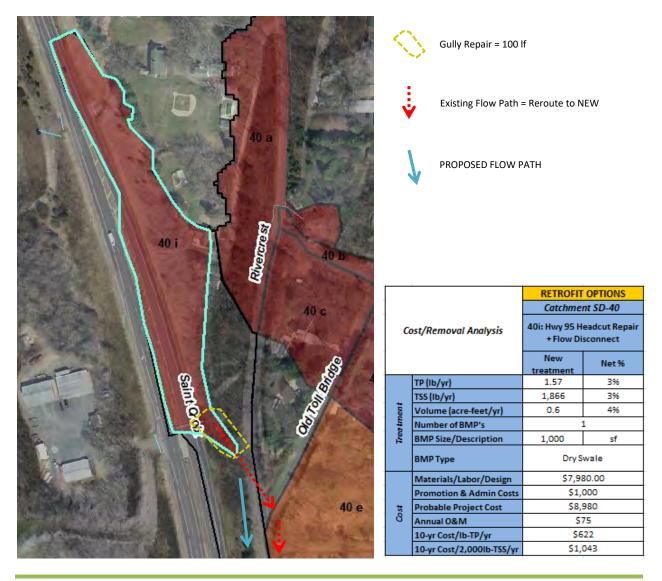
BMP-40i: Hwy 95 Headcut Repair + Disconnect

Location – Hwy 95, NW of intersection of Old Toll Bridge Rd and Rivercrest Rd *Property Ownership* – Public/Private

Description – The Highway 95 ditch outlets onto a steep wooded slope west of Rivercrest. It may have been originally intended for these flows to stay on the west side of Rivercrest, where it would outlet to a large basin between Rivercrest and Hwy 95 just 1,000 feet to the south. But over the years it appears that flows were too strong for this slope and erosion deposits have blocked the flow path. Now water is rerouted across the street to the east side of Rivercrest and flows to Gully 40f. This practice will utilize riprap to armor the eroded gully between Hwy 95 and Rivercrest (to stop further erosion and sediment buildup). This will also require the removal of sediment buildup along the west side ditch of Rivercrest to reestablish the old flow path. Some riprap may be needed to help turn water to ditch; and it may be beneficial to create a larger area for more sediment to settle at the toe of this gully slope so that the practice can endure with minimal maintenance. This practice will result in 100% flow disconnection from Gully 40f.

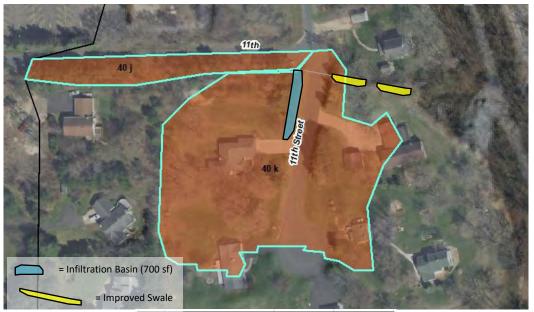
BMP-40j + 40k: 11th St Infiltration System

Location – Intersection of 11th St N and 11th St Ct N *Property Ownership* – Public/Private

Description – These practices will reduce flow to an existing gully that flows straight east from the intersection of 11th St N and 11th St Ct N. Proposed is a 1,000 sf linear infiltration basin on the SW corner of this intersection. Amending the culvert with a new structure may be necessary to achieve 12" of ponding before flows cross the road to the east. On the east side of the road is a chain of mown swales that flow to the gully head. At a minimum, collaborate with the homeowners to stop mowing the swales. As proposed, widen the narrow swale bottom to 4', rip the soils to expose the native sandy soils, and plant the swales with native perennials. Insert checkdams to promote 6" maximum ponding. It is unclear as to the extent of erosion downstream from this point; as access to the private properties were limited at the time of this study.

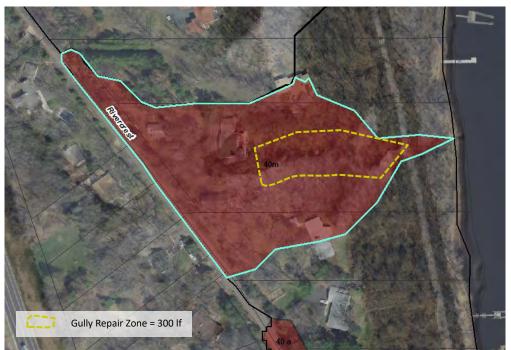
Location – South of intersection of Rivercrest and Hwy 95
Property Ownership – Private

Description – This site was discovered through a homeowner site-visit. There is a very large cut from an access path to the river that has been eroding heavily for many years. The proposed practices include installing flexible waterbars all the way down the path to divert water safely to the bottom of the slope. The existing cuts will be revegetated and some toe stabilization work will also occur at select points along the flow path to prevent further erosion. This site was modelled with only the BWSR Pollution Reduction Spreadsheets. Therefore all pollution reductions are from preventing further erosion and are not from infiltration practices.

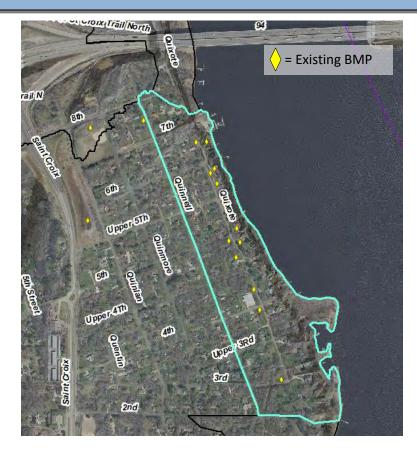
Catchment SD-41 is 61.39 acres. It is mostly Medium to Low Density Residential and is located just south of Interstate Highway 94, in the City of Lakeland. Much of the street drainage (until recently) would drain to several outfalls at the top of the bluff. These outfalls would cause considerable erosion and bluff instability.

This catchment has 12 major infiltration and bluff stabilization practices that were recently installed as part of a concerted effort by the City of Lakeland and the MSCWMO (marked with yellow diamonds). Most of the available land for viable practices in the right of way has already been used for these practices. Therefore, there is not much area left to recommend new practices that are worth the cost of installation. As a result, this study did not recommend any new practices for SD-41.

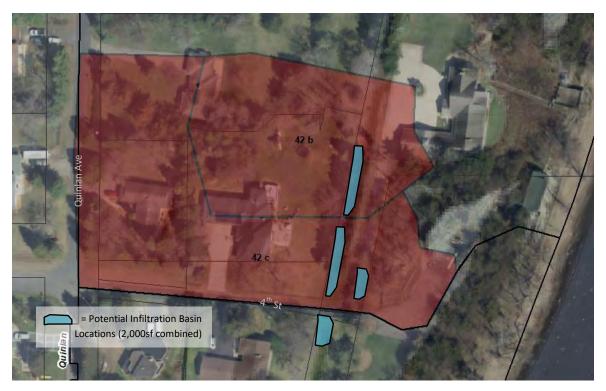
BMP-42b+c: 4th Street Redirect and Infiltration

Property Ownership – Private/Public

Description – There are two gullies that are very close to the existing houses on the bluff. This series of practices will divert flow away from the bluff and into multiple infiltration practices as shown. Size and depth of each basin will vary depending on field verified site-constraints; but they were modelled at 6" ponding depth over 2,000 combined square feet. Basins along 4th St will receive water via channel drains installed on 4th.

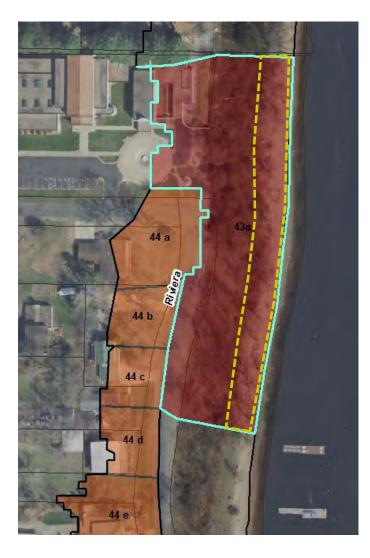
Drainage Area – 1.72 acres

Location – Intersection of 13th St S and Riviera Ave S Property Ownership – Public

Description – This bluff is eroding at a very fast pace. Increasing frequency of near-record elevation floods along the St Croix River have pushed the stability of the bluff toe to the limit and have caused some significant losses in recent years. This project will stabilize the bluff toe with 'grouted riprap' to the 992' elevation. Some trees will have to be selectively thinned, and riprap will have to be strategically placed in order to balance their respective visual and ecological impacts.

= Toe Stabilization to 992' = 515 lf

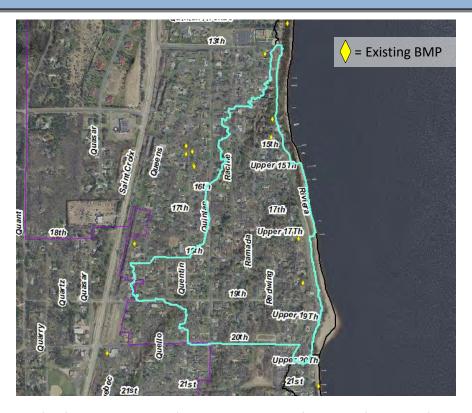
Catchment SD-44

There are 4 known existing practices. All are infiltration basins on residential property. The WinSLAMM model also factored in the partial-disconnection of the western half of the catchment. This is reflected in the Existing Conditions table above, where a 31% reduction is shown. The model only discounted 50% of the flow from this catchment, where in reality it may be much larger. The exact value is unknown though, since it would require extensive field investigation to document the size and depth of natural depressions and infiltration features that contribute to this flow reduction.

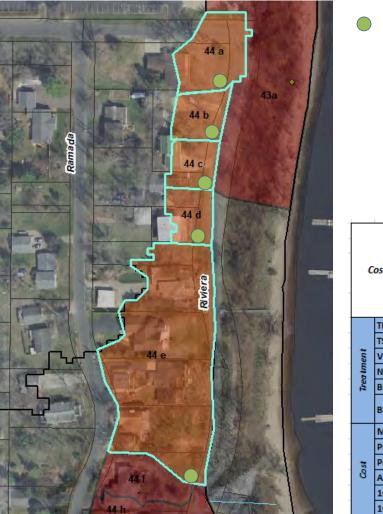
Location – Riviera Ave S, from 13th St S to approx. 14th St outfall *Property Ownership* – Private/Public

Description – This catchment has very sandy soils, but also fairly steep slopes with mown lawns. This treatment train of infiltration swales will help control discharge rates to the outfall, as well as promote infiltration for modest pollution reductions. Each point on the map below represents a 150sf turf swale, up to 12" deep, and connected to the native sandy soils (may require some deep ripping of existing compacted soils). Inlets to the swales would be by amending the sod elevation along the street edge. This would allow water to enter along the full length of the practice - as opposed to the current system of sediment buildup along the street edge, forcing all road runoff to the outfall (untreated). These systems can be designed to be offline as well, if inlets are at controlled points along a new curbline. Further, this system could rank much higher if it is determined that minimal excavation work has to be done to achieve desired infiltration rates (thus lowering the total cost).

= Swale Location (approx. 150sf each)

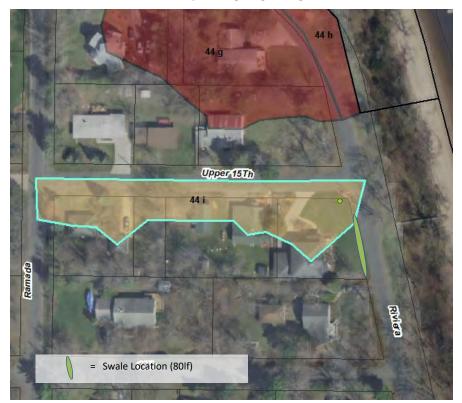
Location – Riviera Ave S, at Upper 15th St *Property Ownership* – Private/Public

Description – This site was one of very few opportunities that could capture more than 200lf of roadway. Although the ROW is very narrow (6'), it is still possible to install a shallow swale (8" depth) that can fit within the ROW. The slopes would be 3:1, and the practice could be up to 80lf. Underground utility conflicts are unknown. This practice could be much larger if an agreement with the property owner were reached to allow some ponding or grading outside of the ROW.

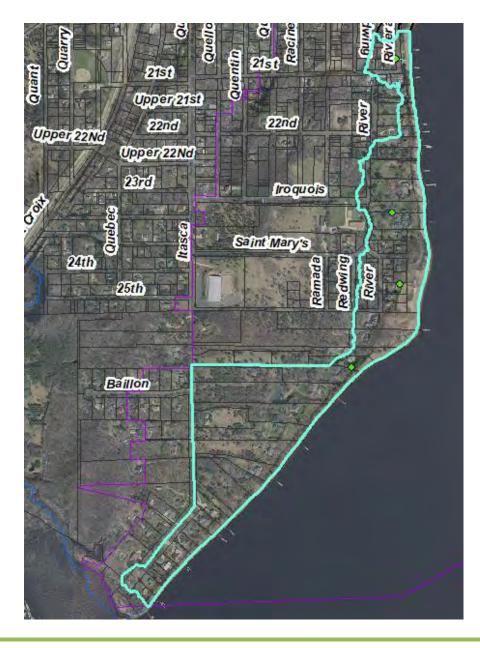
The properties at the green points were identified as having potential erosion control opportunities, based on inspection of the Digital Elevation Model and 2016 Aerials. There was no field investigation of these sites, but they could be included as priority outreach targets if such an effort was undertaken.

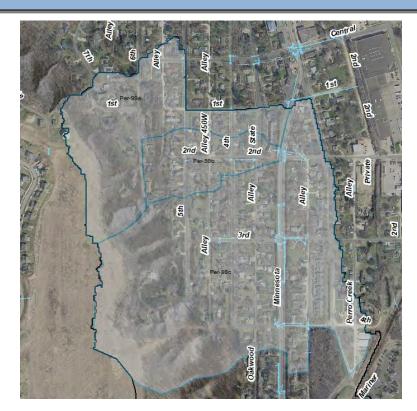
Catchment PER-99* (UNRANKED)

EXISTING CONDITIONS							
	Existing Conditions	Base Loading	Treatment	Net Treatment %	Existing Loading					
	TP (lb/yr)	79.2	3.8	5%	75.4					
	TSS (lb/yr)	32,288	1,510.0	5%	30,778					
ent	Volume (acre-feet/yr)	53.99	0.0	0%	53.9					
Trea tmen	Number of BMP's									
Te.	BMP Size/Description									
	BMP Type	600lf of mown swales

CATCHMENT DESCRIPTION + EXISTING STORMWATER TREATMENT

Catchment PER-99 is 120.38 acres. It is comprised primarily of Medium Density Residential (with alleys), as well as Bluff space that is categorized as either Open Space or Undeveloped (depending on observed understory condition). This catchment was UNRANKED for two reasons. 1) It was not initially included in the study area since a portion of it drained to Perro Creek. 2) The catchment received direct treatment of runoff via multiple swales, a large wooded depression, and a stormpond before discharging to the St Croix River. After gaining a better understanding of the actual vs modelled catchment boundaries, as well as seeing firsthand the actual volume of runoff discharging from this catchment, it was decided to include this catchment in the study. Even though the system does get some treatment at the end of the catchment, the state of this treatment system is inadequate to address the volume of discharge. The study recommends two practices to implement, along with others to consider after further feasibility studies are undertaken.

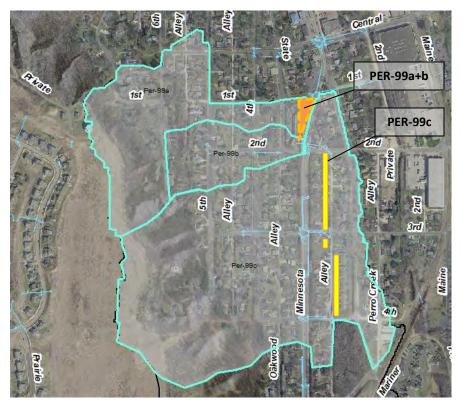
RANK 10 to 19/19 - BMP PER99a – 1st and Hwy 95 Infiltration Basin : Redirect 1st and 2nd St flows into large Infiltration basin on Main. Some utility movement required. Washington County has plans for bike path here as well.

RETROFIT OPTIONS								
		Catchment PER-99								
Cost/Removal Analysis		BMP PER-99a+b: 1st St and Hwy95 Infiltration Basin			c: Alley Swale cement	Total Reductions (all implemented)				
		New trtmt	Net %	New trtmt	Net %	New trtmt	Net %			
	TP (lb/yr)	10.8	14%	2.5	3%	13.3	18%			
tment	TSS (lb/yr)	4580	15%	907	3%	5487.0	18%			
	Volume (acre-feet/yr)	6.9	13%	0.05	0%	7.0	13%			
	Number of BMP's	1		1		2				
Trea	BMP Size/Description	8,000	sf	2,400 sf		All Practices				
	ВМР Туре	Highly Comple	x BioFiltration	Unmown Swa	le Minimal Veg					
	Materials/Labor/Design	\$201	,000	\$1,	,190	\$238,510.00				
	Promotion & Admin Costs	\$6,	000	\$500		\$7,300.00				
est B	Probable Project Cost	\$207	,000	\$1,690		\$245,810.00				
8	Annual O&M	\$7	20	\$360		\$2,0	00.00			
	10-yr Cost/lb-TP/yr	\$1,	985	\$2	212	\$1,	098			
	10-yr Cost/2,000lb-TSS/yr \$9		354	54 \$1,166		\$5,260

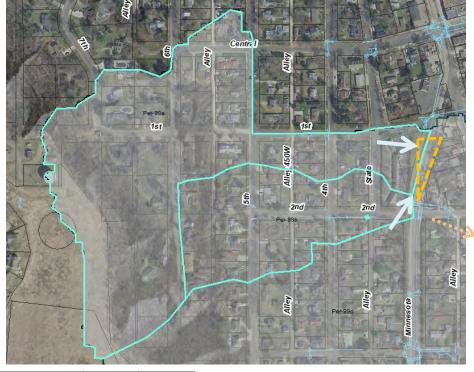
BMP PER-99a+b: 1st St and Hwy 95 Infiltration Basin

Location – Between 1st and 2nd St on Highway 95 Property Ownership – Private/Public

Description – This site was identified as a major volume control practice. It is an infiltration basin that would occupy the Right of Way (and some private property). The basin was modelled at 8,000 sf, with 1.5' of ponding capacity and 2' of amended soils. An underdrain system would be connected to the existing stormsewer network. Replacement of 2 structures would be necessary; as well some creative grading or pipework to get flows to bypass the existing culvert under Hwy 95 and into the proposed basin. This system would preferably be an offline design. The cost of this basin is highly dependent on how many utilities have to be relocated, as well as what Washington County's plans are for the proposed bike trail that is to go through or adjacent to this site. The cost could be as low as \$100,000 or as high \$200,000+. This range in price is why there are two rankings for this practice. Either way, the volume and pollutant load reductions are high enough to rank this practice fairly high in any other given SWA.

RETROFIT	OPTIONS		
		Catchment PER-99			
		BMP PER-9	9a+b: 1st St		
	Cost/Removal Analysis	and Hwy95	Infiltration		
		Ba	sin		
		New	Net %		
		trtmt	ince //		
	TP (lb/yr)	10.8	14%		
	TSS (lb/yr)	4580	15%		
	Volume (acre-feet/yr)	6.9	13%		
nen	Number of BMP's	:	1		
Trea tment	BMP Size/Description	8,000	sf		
	ВМР Туре	Highly Complex BioFiltratio

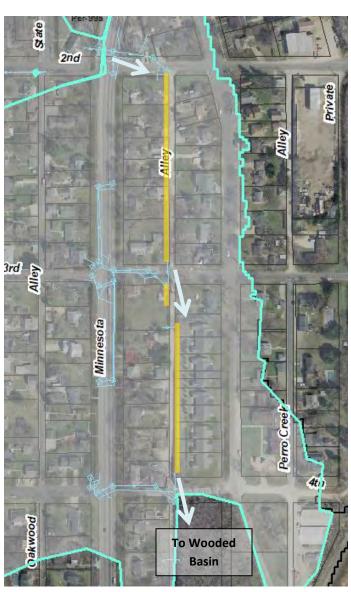
Location – Alley Swales from 2nd Ave to 4th Ave S, between Highway 95 and 3rd St S **Property Ownership** – Private/Public

Description – The swales between these alleys are merely for conveyance of about 100 acres of runoff to the St Croix River. It is recommended that some additional treatment can be gained just by not mowing these swales. It could also be recommended to widen the swales, but additional width will not make as much of a difference as just having taller vegetation in the swales. This is an incredibly inexpensive BMP and would be a best practice for any ditch system.

Cost/Removal Analysis		RETROFIT OPTIONS Catchment PER-99 BMP PER-99c: Alley Swale Enhancement			
		New trtmt	Net%		
	TP (Ib/yr)	2.5	3%		
	TSS (Ib/yr)	907	3%		
ant.	Volume (acre-feet/yr)	0.05	0%		
rea tmen t	Number of BMP's	1			
Trea	BMP Size/Description	2,400	sf		
	ВМР Туре	Unmown Swal	e Minimal Veg		
	Materials/Labor/Design	\$1,3	190		
	Promotion & Admin Costs	\$500			
ta ta	Probable Project Cost	\$1,690			
8	Annual O&M	\$3	60		
	10-yr Cost/lb-TP/yr	\$2	12		
	10-yr Cost/2,000lb-TSS/yr	\$1,	166

RANK 02/19 - **BMP PER99b** – **Alley Swale Enhancement:** Convert existing mown swale to unmown. Can selectively integrate native plugs where appropriate (for higher install cost).
