LITHOLOGY KEY

HYDROSTRATIGRAPHIC PROPERTIES KEY

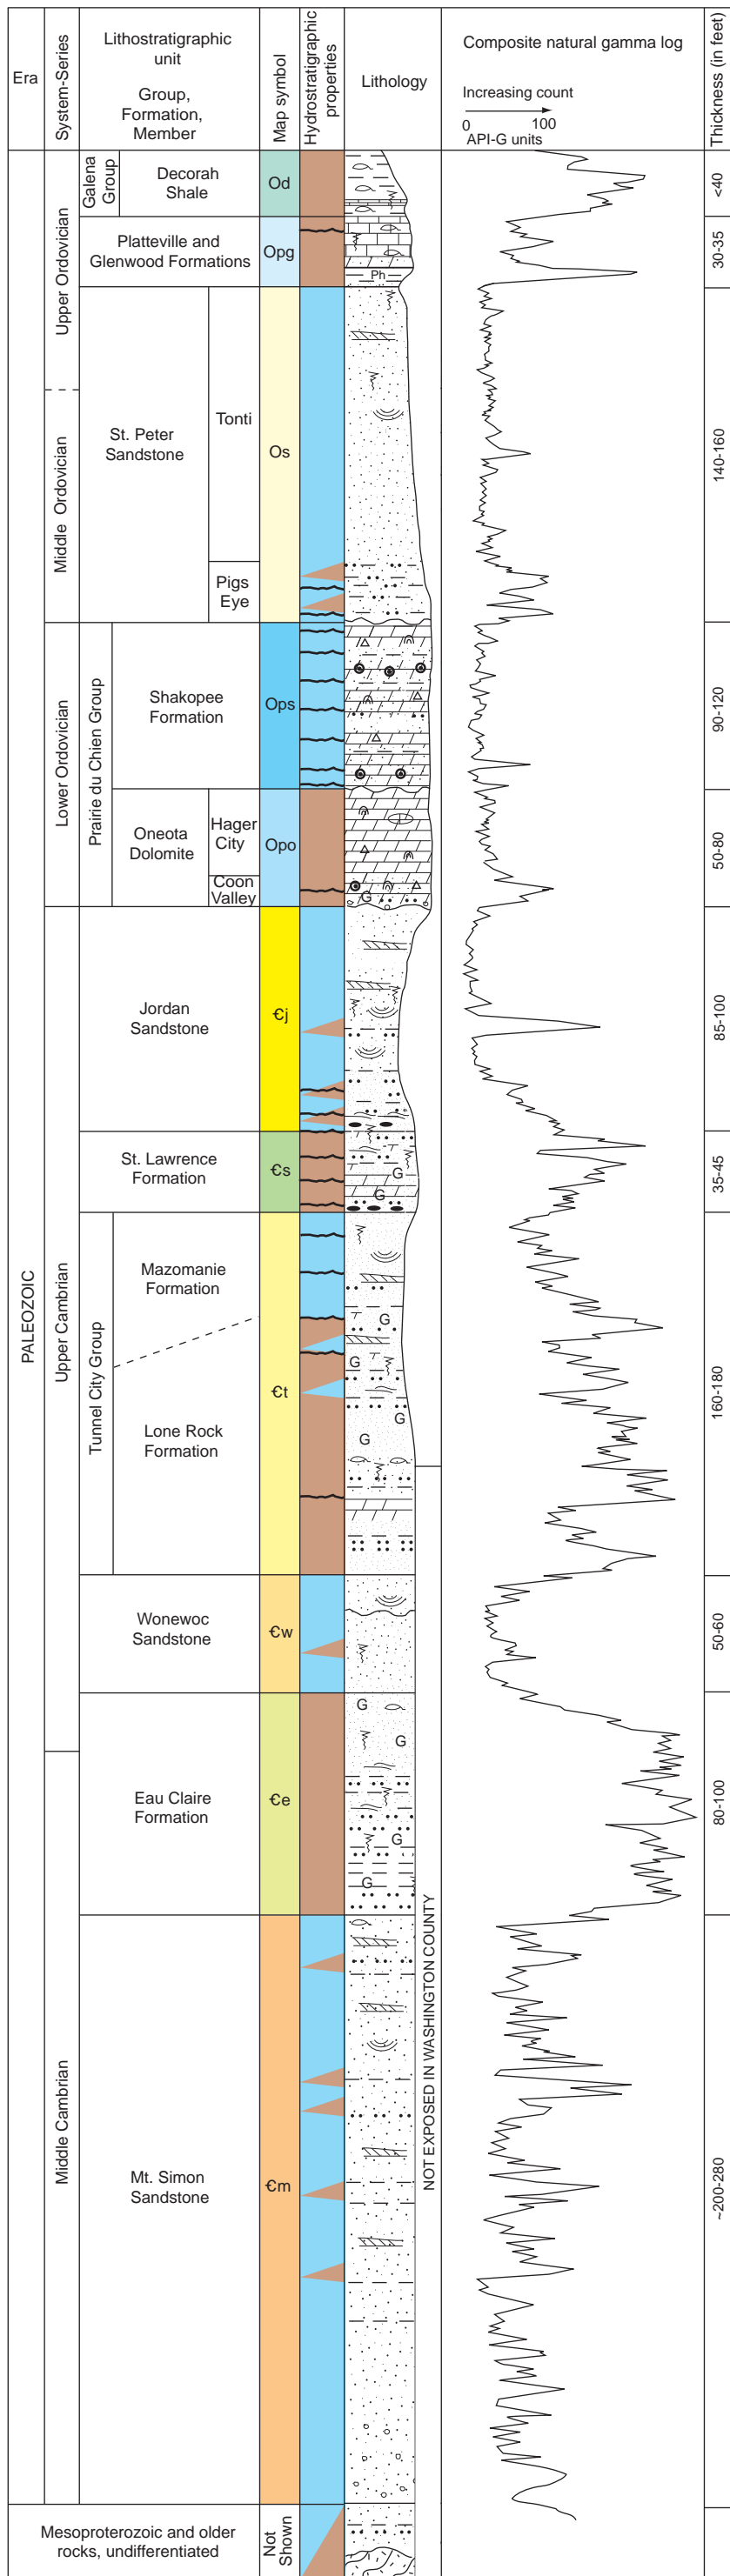
High permeability bedding fracture known to be common

NOT EXPOSED IN WASHINGTON COUNTY
